SURFACE INTEGRITY OF MACHINED STRUCTURAL COMPONENTS

Metcut Research Associates Inc.
Cincinnati, Ohio

Technical Report AFML-TR-70-11
March 1970

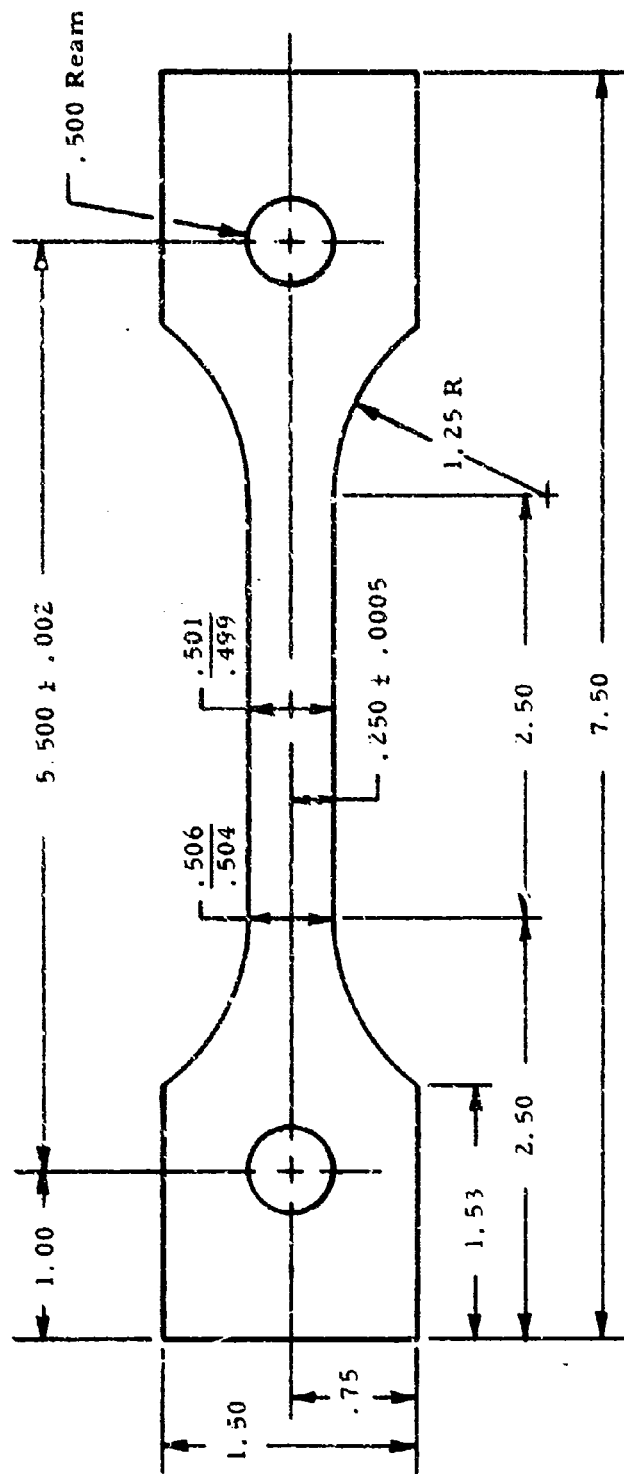
STRESS CORROSION SPECIMEN FOR TITANIUM

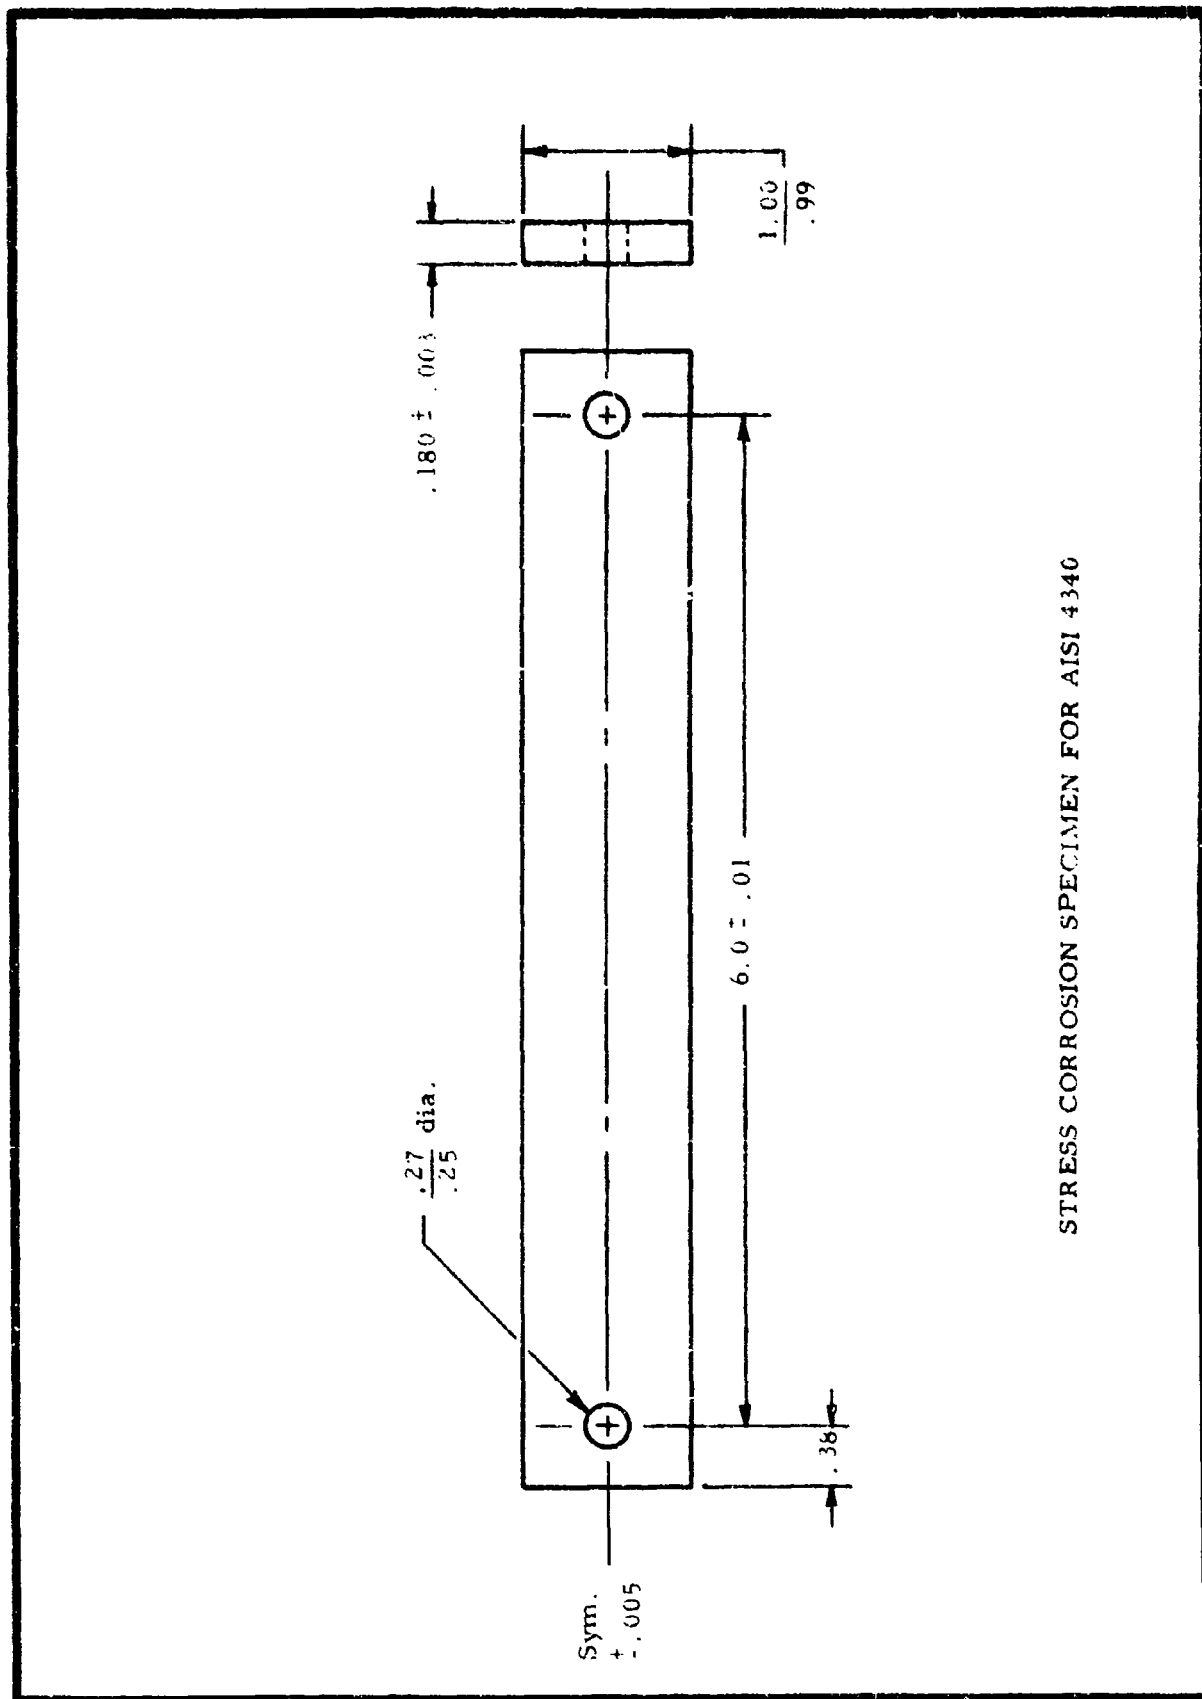
STRESS CORROSION SPECIMEN FOR AISI 4340

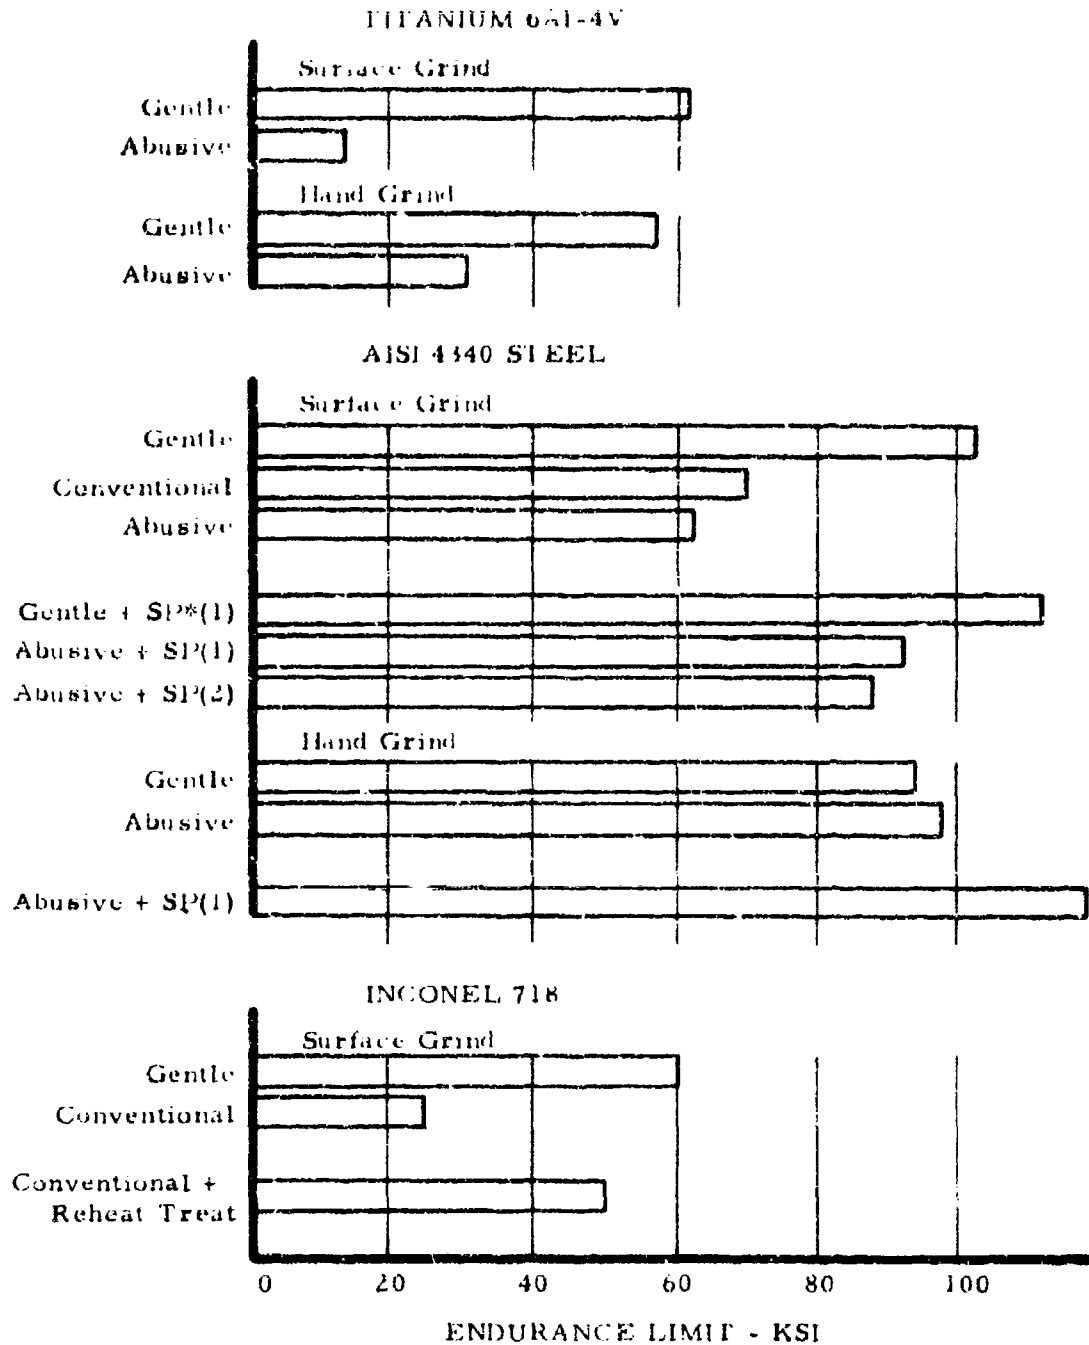
FATIGUE STRENGTH COMPARISONS OF VARIABLES IN GRINDING

*SP = Shot Peen; () No. in Parentheses Shot Peening Level

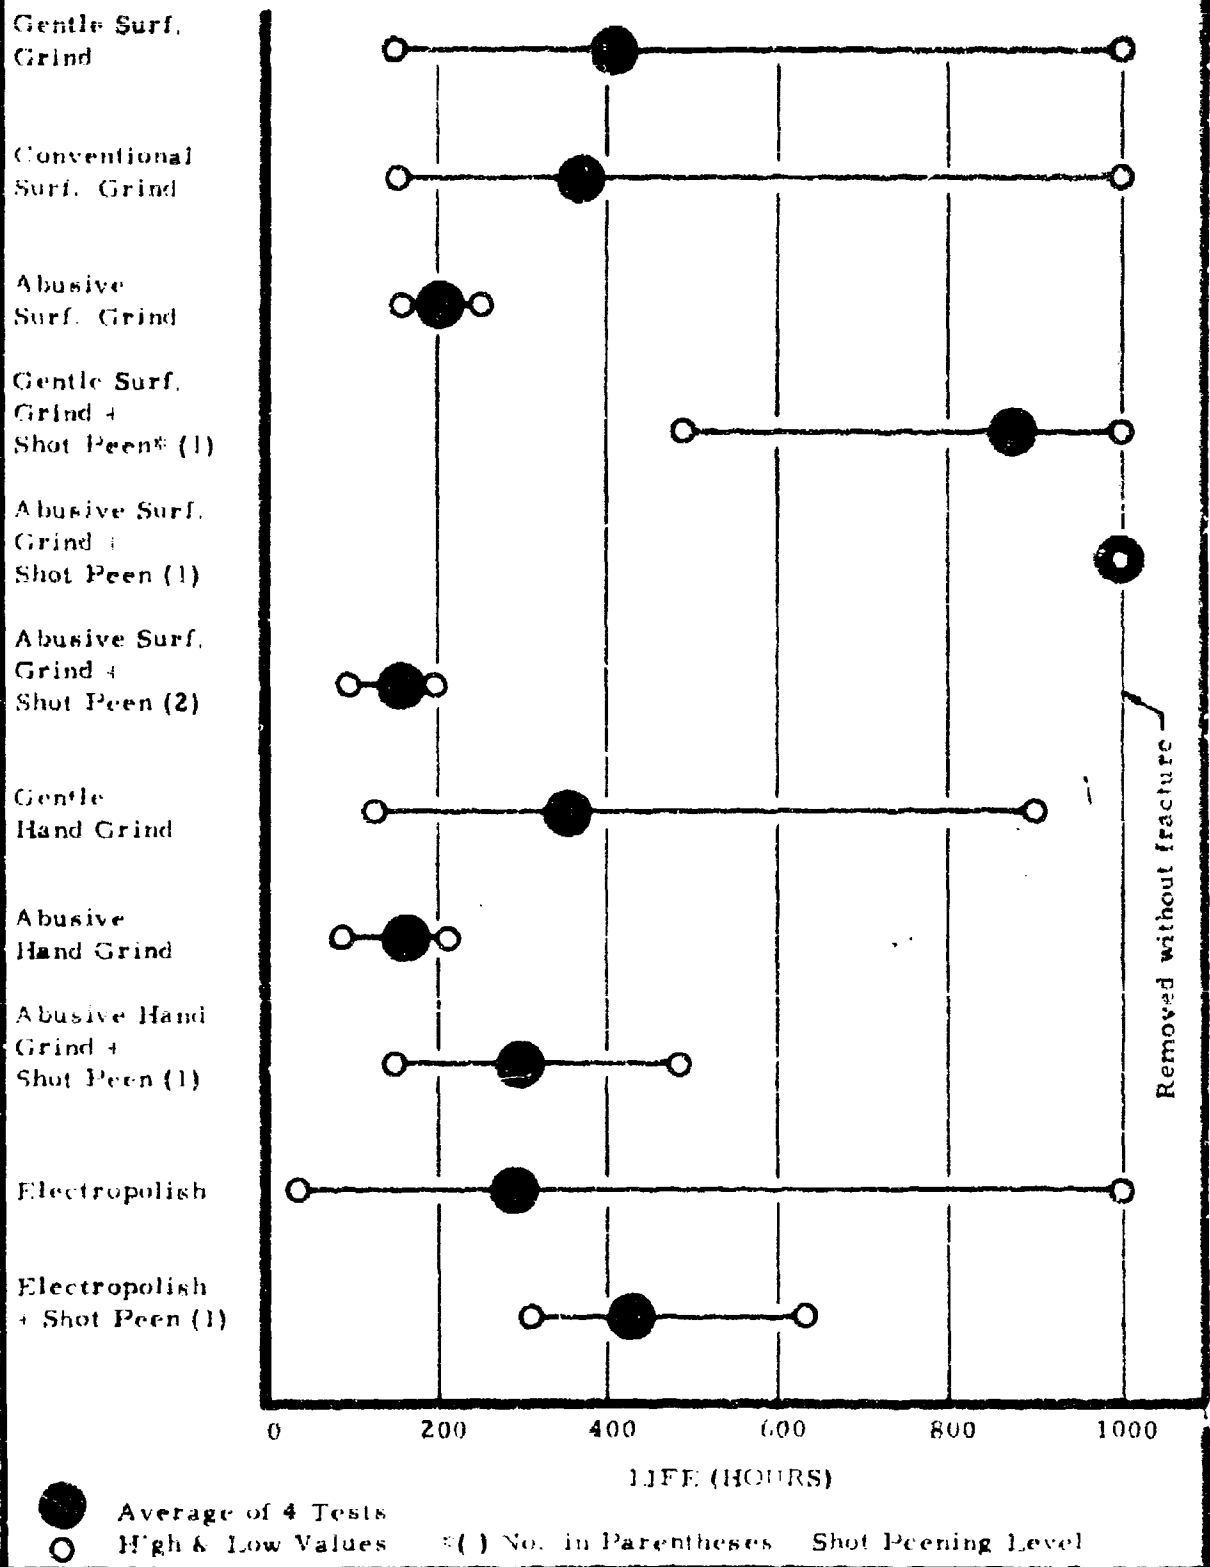
SUMMARY OF STRESS CORROSION BEHAVIOR OF AISI 4340

Indicated as life in alternating salt water-air exposure when stressed to 165 ksi,

7. Under the salt exposure conditions studied, titanium showed no consistent relation between metal removal method and stress corrosion sensitivity (Figure 9). The stress corrosion tests on 4340 steel yielded widely scattered data. One significant trend, although not entirely consistent, was the low life, hence high stress corrosion susceptibility, exhibited by abusively ground samples. (Figure 10)

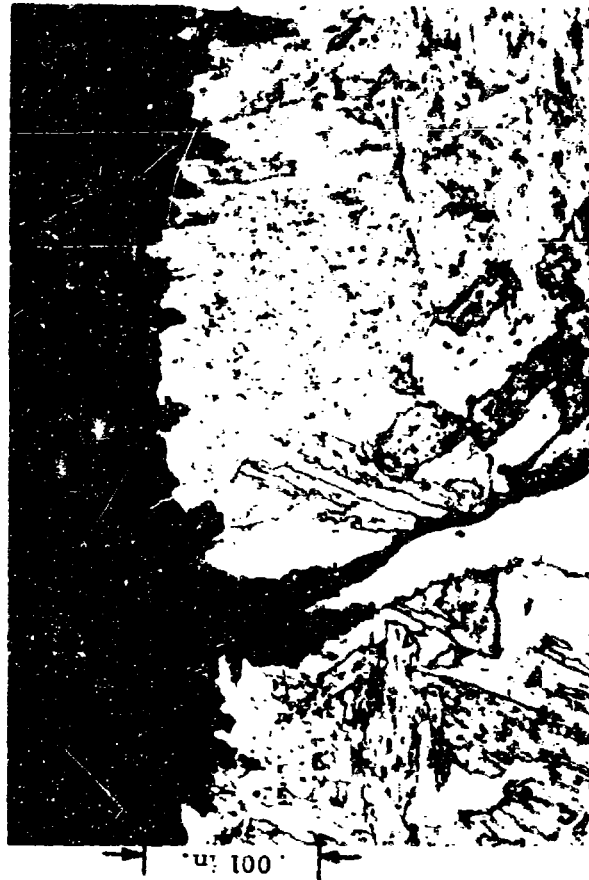
(a) Gentle Conditions - Slight surface irregularity but without other measurable effects.
Surface Finish: 18 AA 1000X

(b) Abusive Conditions - Significant surface roughness but without measurable hardness change.
Surface Finish: 205 AA 1000X

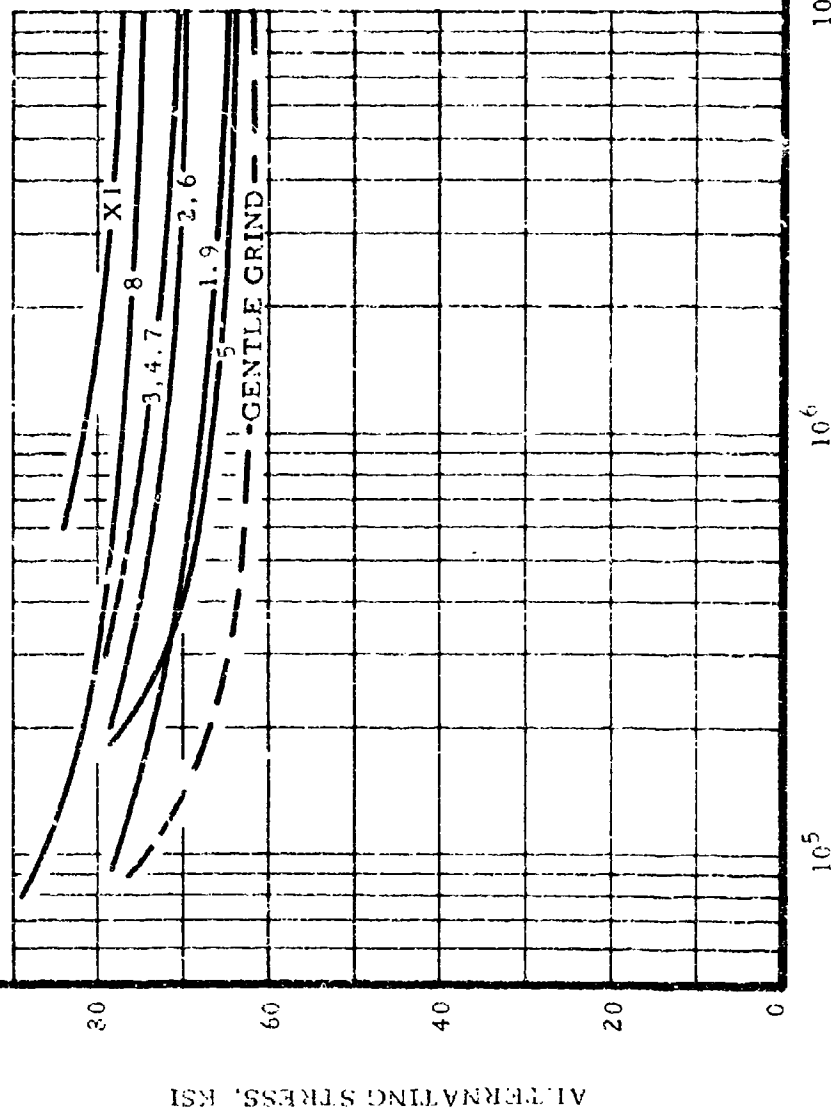
METAL REMOVAL CONDITIONS: END MILLING - END CUTTING
MODE: CANTILEVER BENDING, ZERO MEAN STRESS
TEMPERATURE: 75°F

MILLING CONDITION	ENDUR. LIMIT KSI	SURF. FINISH AA
1	64	74
2	70	53
3	72	82
4	72	57
5	64	67
6	70	42
7	72	56
8	75	87
9	64	56
X1	77	84
GENTLE SURFACE GRIND	62	35

13. Variations in milling Ti-6Al-4V cause a wide spread in resulting fatigue strength. In end milling-end cutting, fatigue strengths ranged from 64 to 77 ksi, compared to 62 ksi for gentle grinding. In this operation, tool sharpness is the most influential variable. As the tool becomes duller, hence the operation more abusive, the fatigue strength increases. (Figure 30)

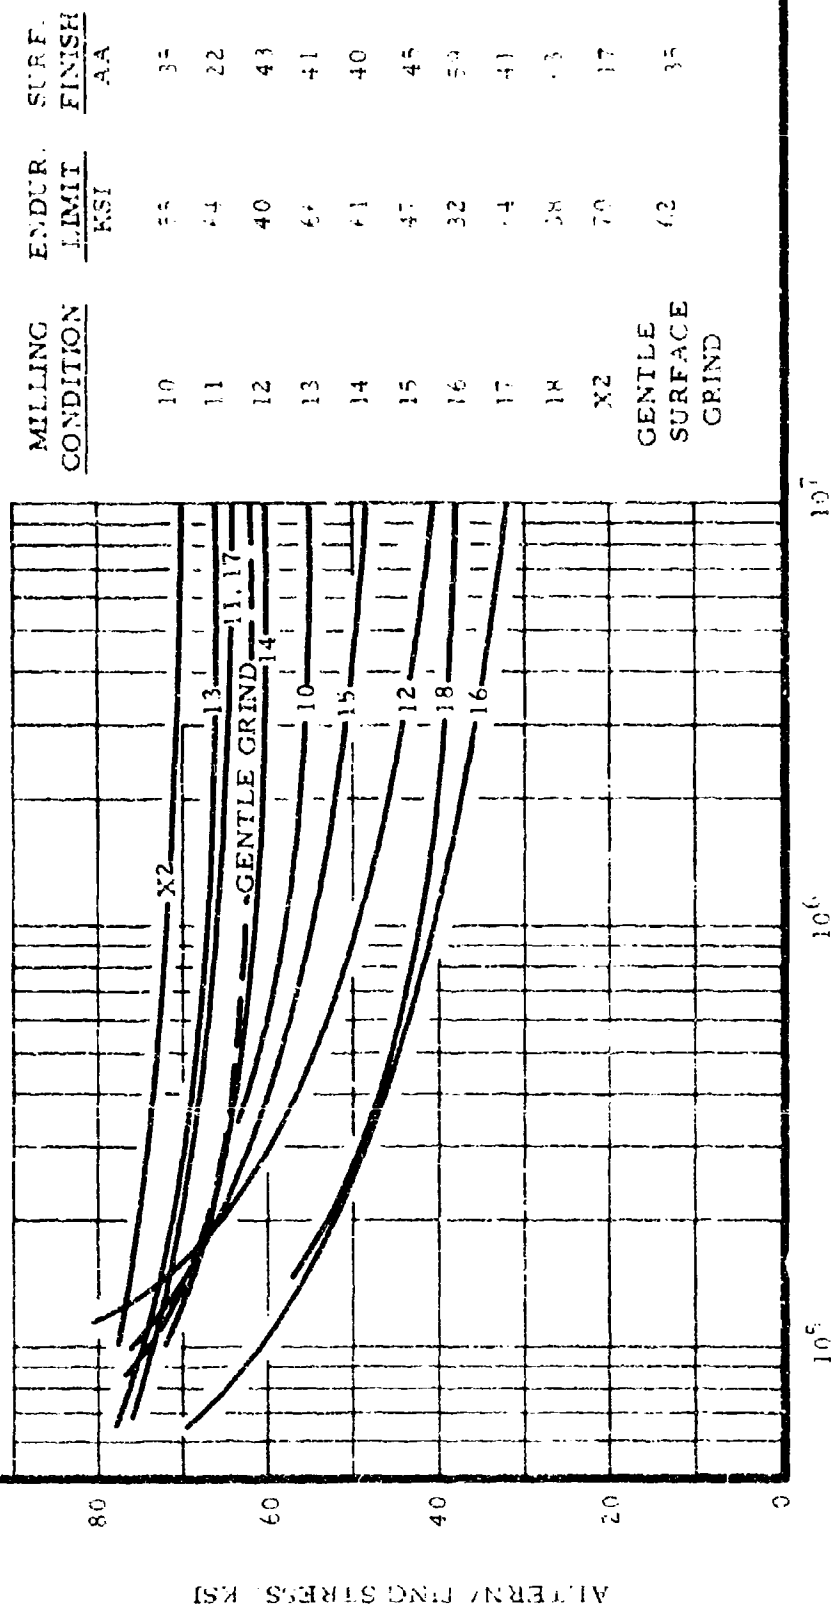
METAL REMOVAL CONDITIONS: END MILLING - PERIPHERAL CUTTING
 MODE: CANTILEVER BENDING, ZERO MEAN STRESS
 TEMPERATURE: 75°F

In end milling-peripheral cutting, tool sharpness is also the biggest factor, but as the tool becomes duller the fatigue strength decreases. The range of endurance limits associated with peripheral cutting was found to be from 70 ksi down to 32 ksi. (Figure 31)

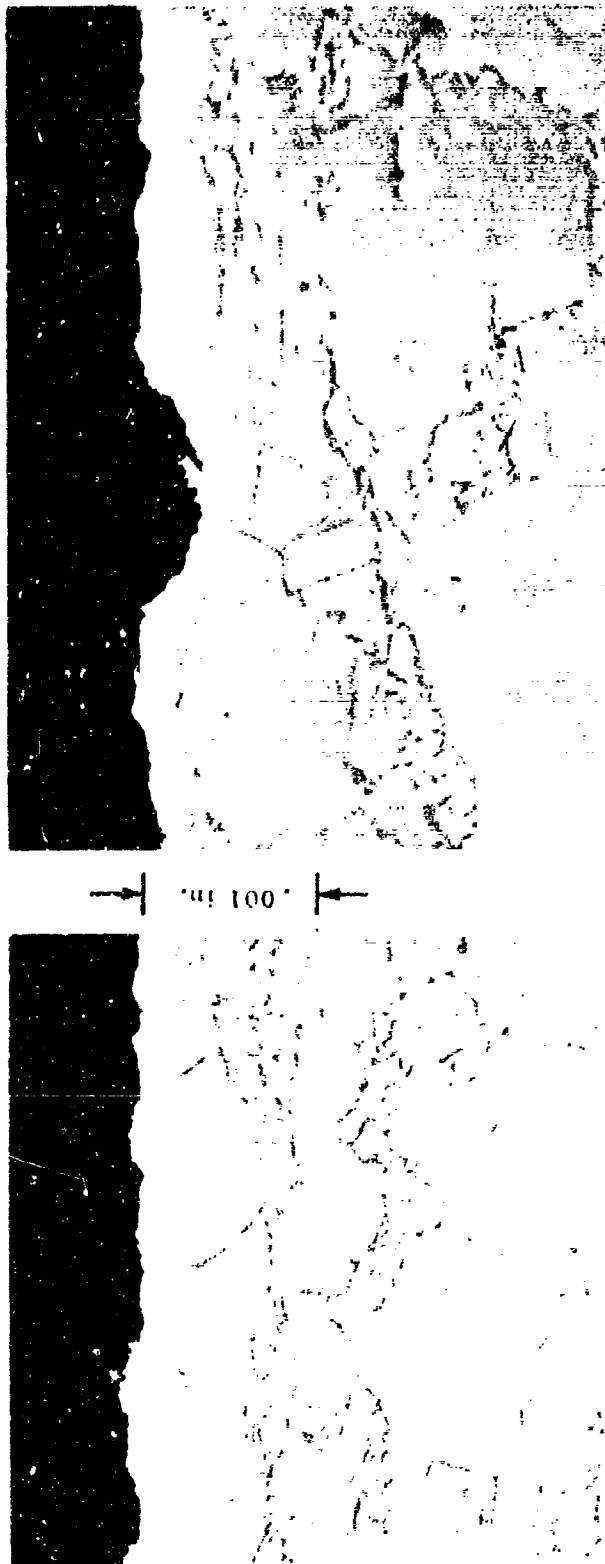
SURFACE CHARACTERISTICS OF
INCONEL 718 (Solution Treated, 98 R_B)
PRODUCED BY CHM

(a) Gentle Conditions - A somewhat irregular surface and slight softening at the surface were produced.
Surface Finish: 45 AA 1000X

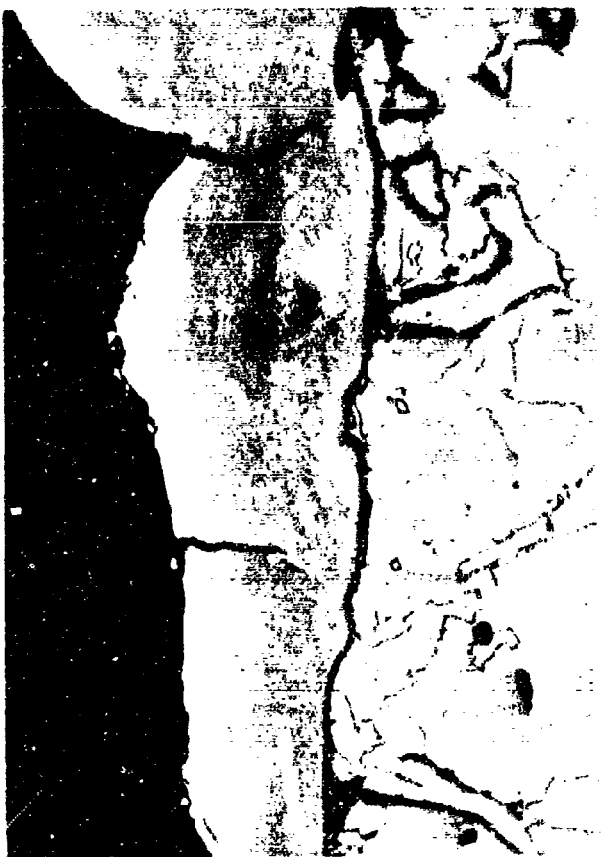
(a) Finishing Conditions - A thin discontinuous recast layer averaging .0001" deep was formed on the surface. 1000X

(b) Roughing Conditions - A variable continuous recast layer up to .002" thick and extensively cracked was formed on the surface. The structure was affected by heat for an additional .002" beneath this surface layer. 1000X

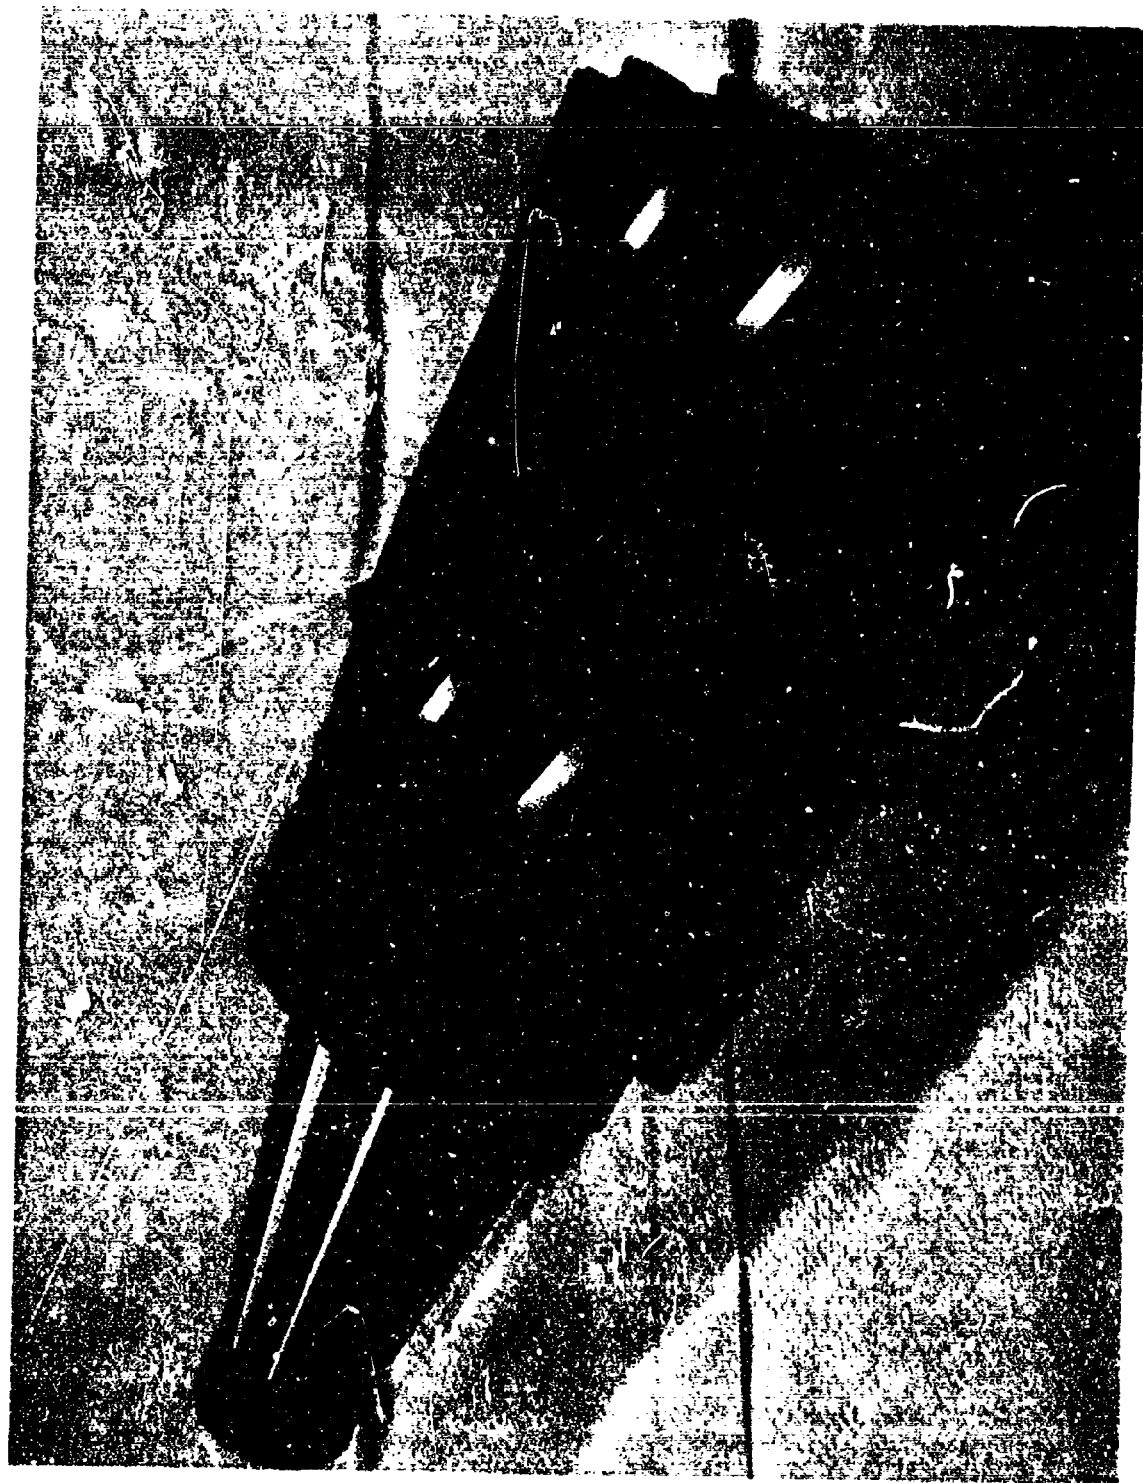
MILLING CUTTER - USED FOR END MILLING, PERIPHERAL CUTTING OF Ti-6Al-4V

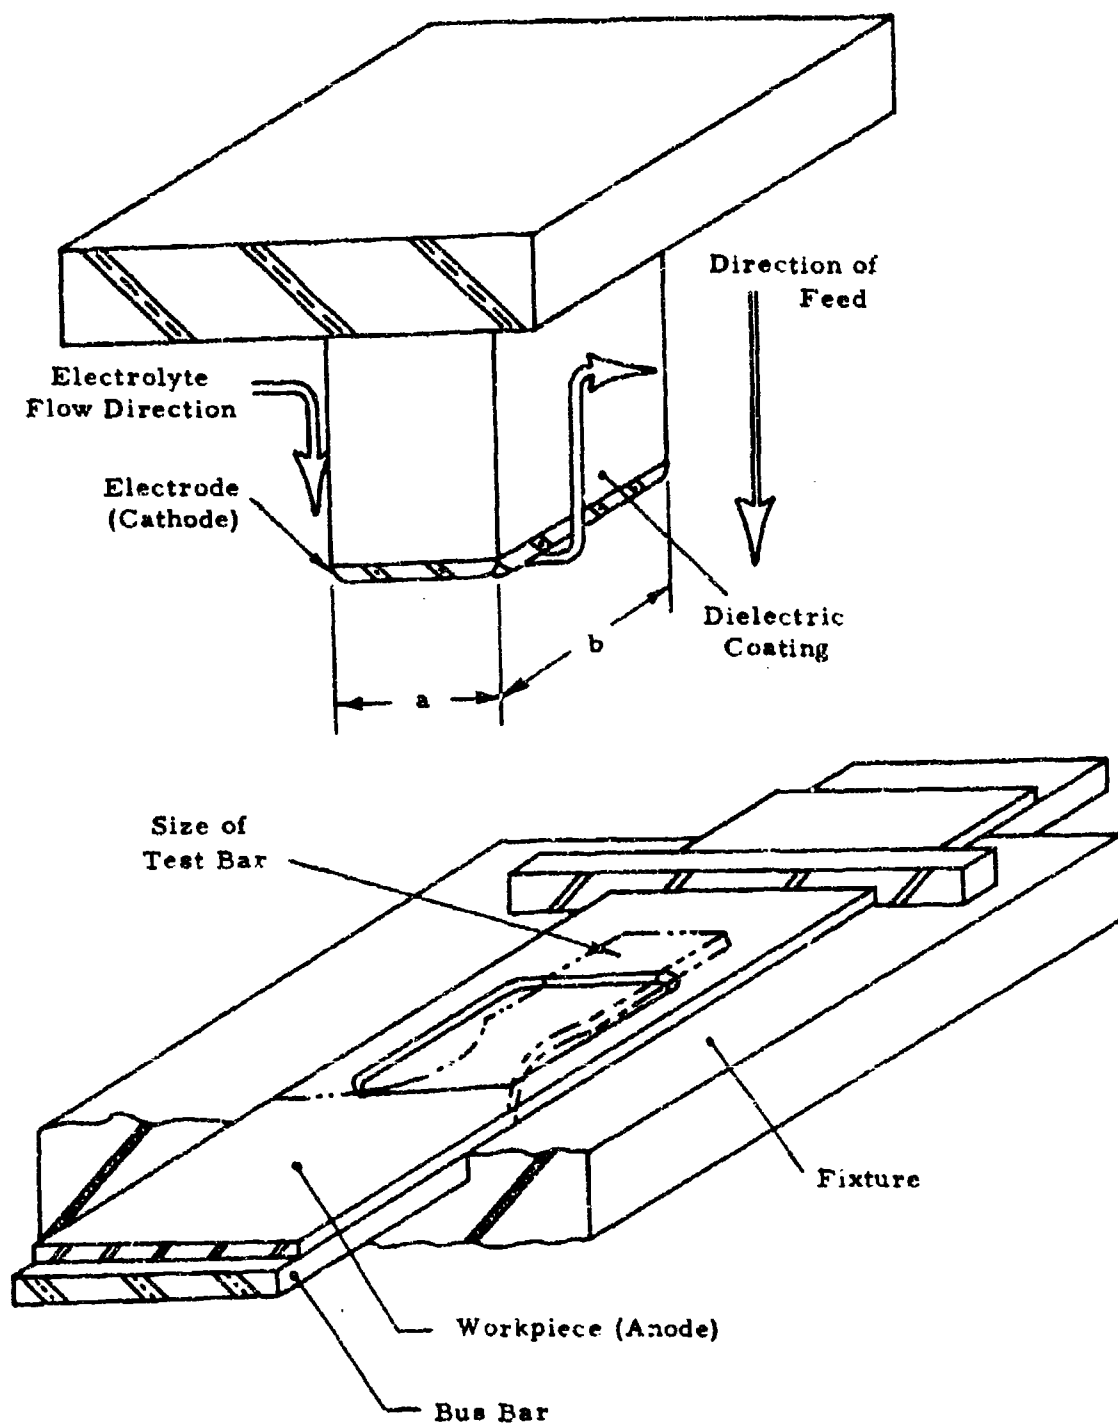
ELECTROCHEMICAL MACHINING - FRONTAL FIXTURING

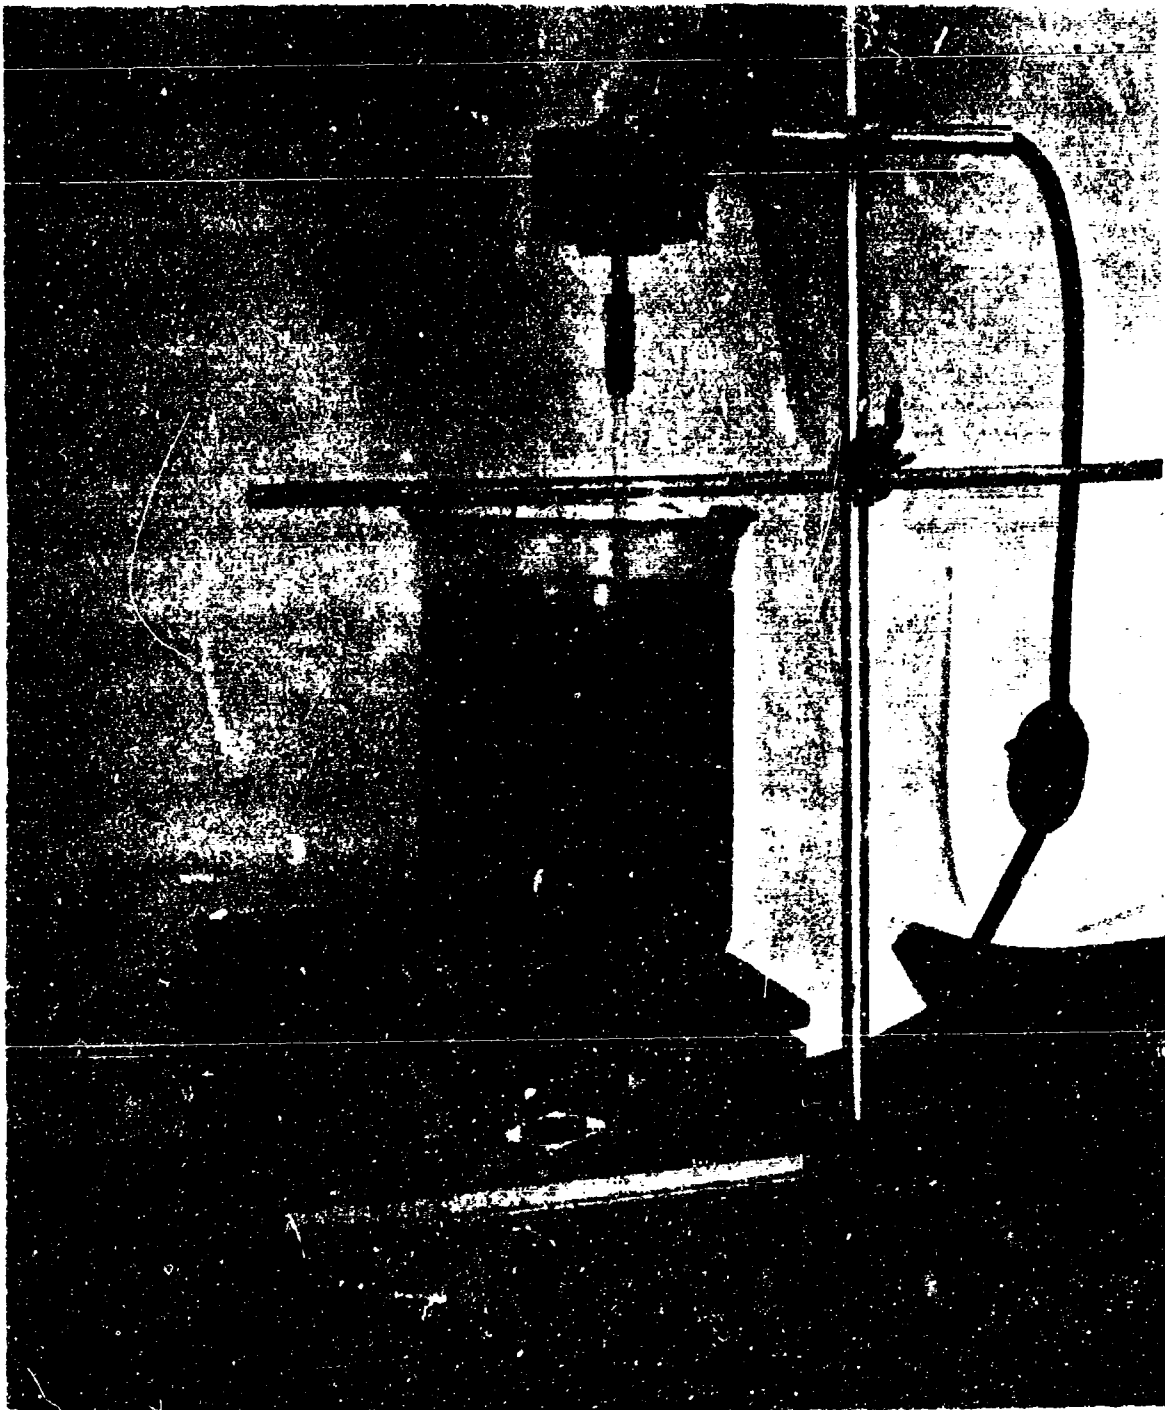
SETUP USED FOR CHEMICAL MACHINING OF COUPONS.

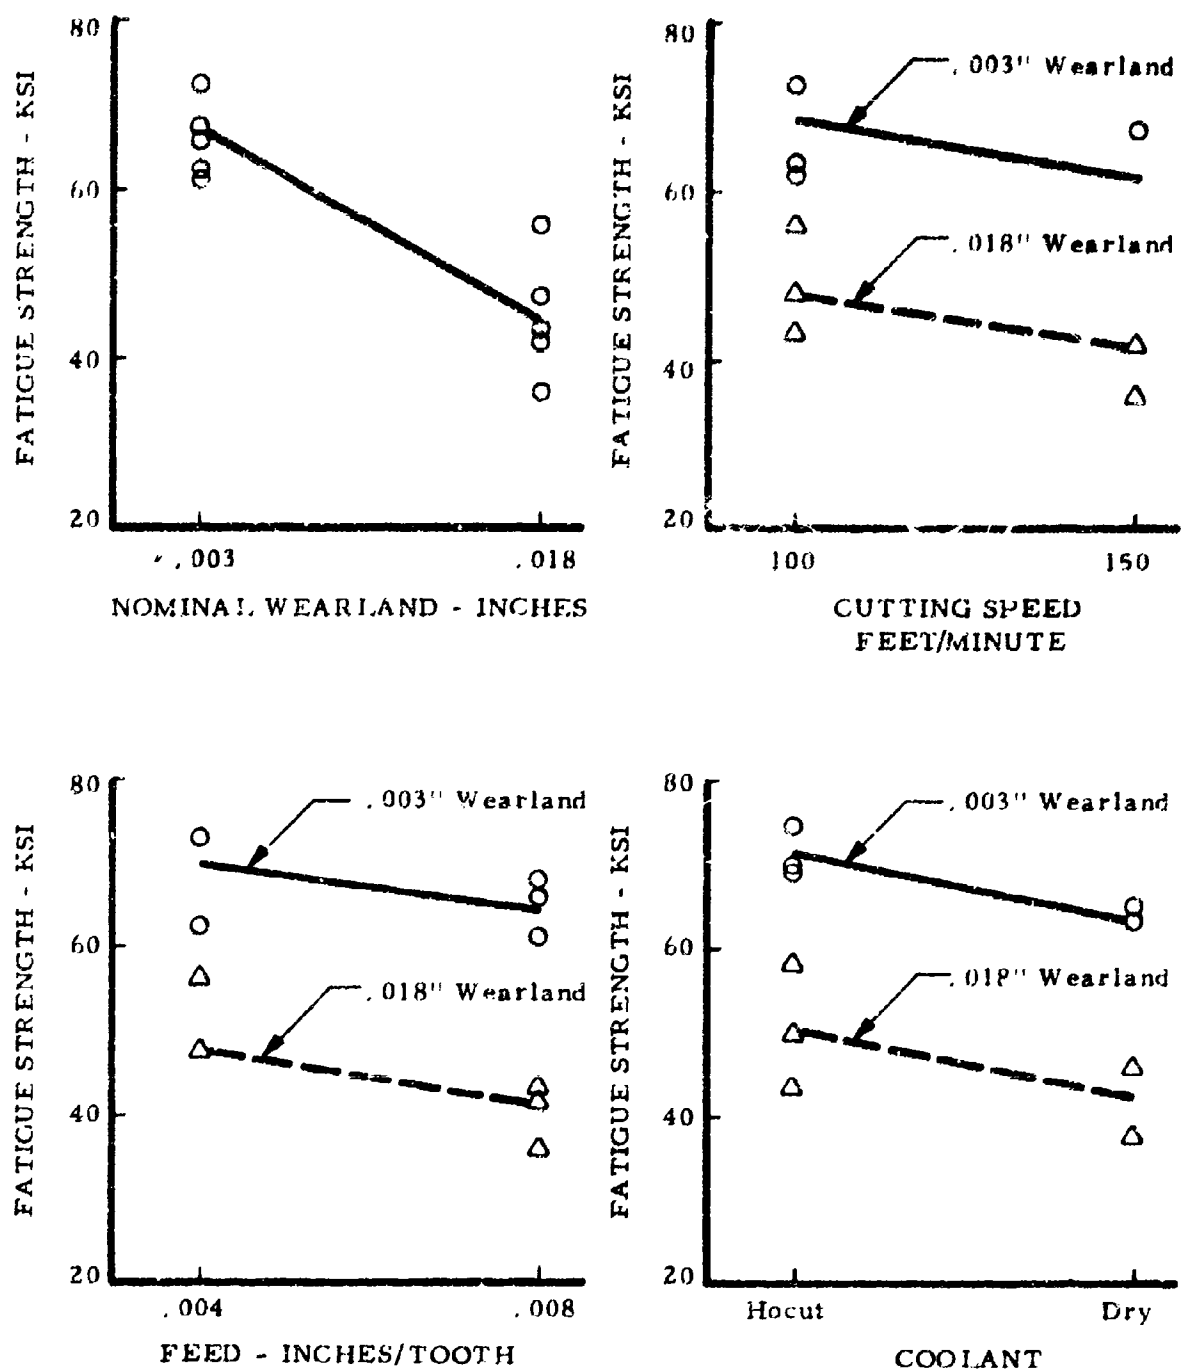
EFFECT OF SIGNIFICANT PERIPHERAL MILLING VARIABLES
ON FATIGUE STRENGTH OF Ti 6Al-4V

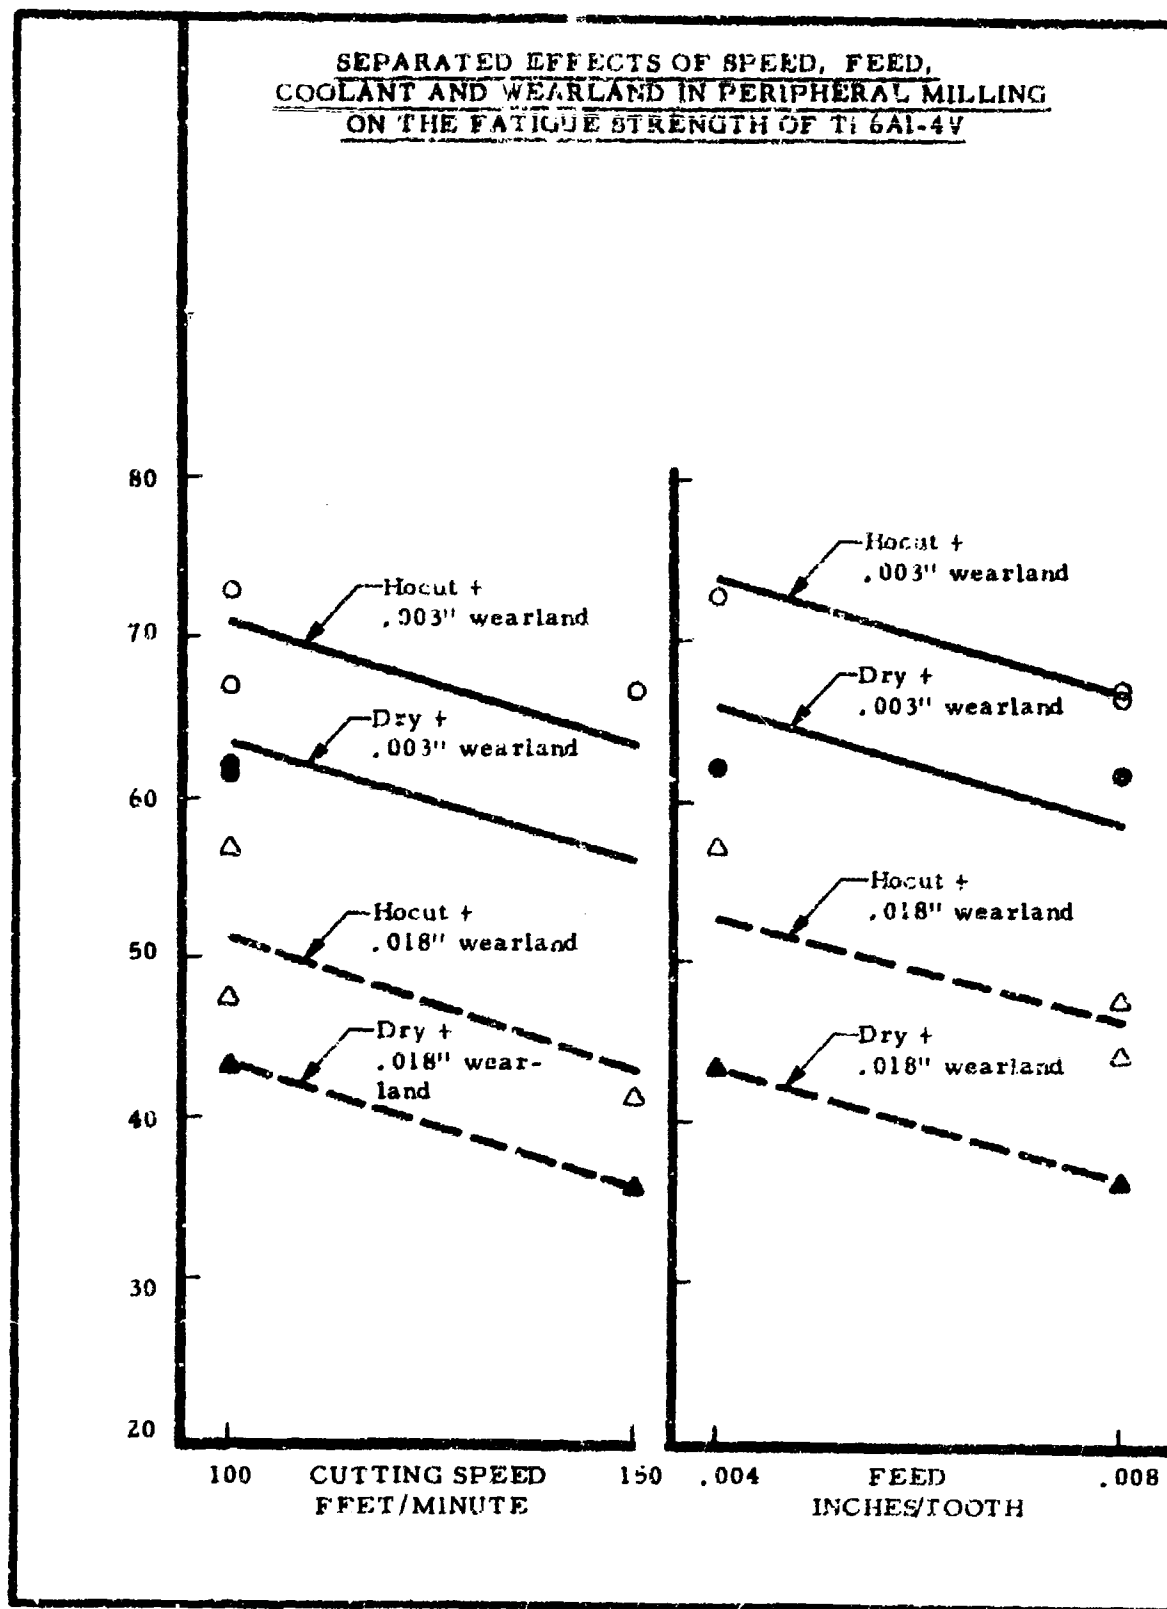
COMPARISON OF OBSERVED VS. CALCULATED
FATIGUE STRENGTH
